Conformal Coating Defect

Pinholes, Bubbles & Foam

Summary

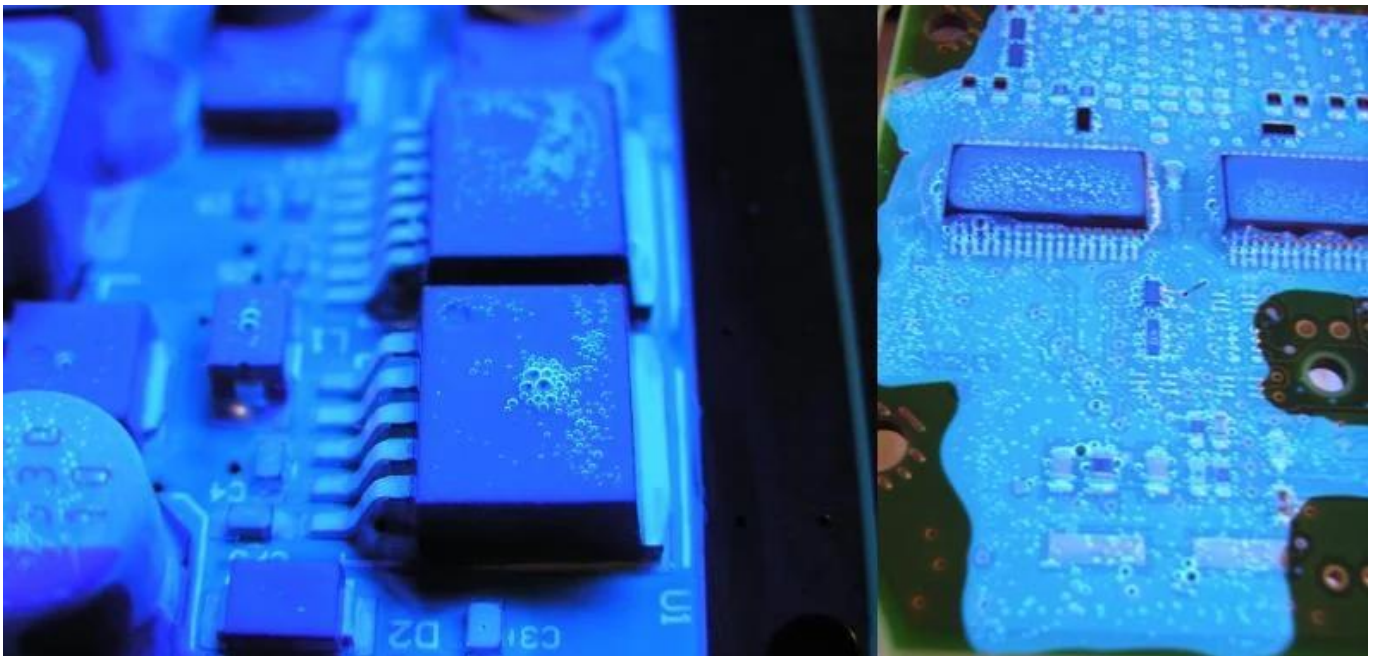
Common issues like pinholes, bubbles and foam regularly occur in conformal coating application and can compromise PCB protection. Understanding how these defects form—and how to prevent them—is key to improving reliability and reducing costly rework.

- Bubbles — trapped pockets of air under the coating film.
- Pinholes — burst bubbles that break through to the PCB surface.
- Foam — extensive bubbling across the coated area.
