Technical Bulletin Sep 08

Common failure mechanisms in conformal coating

Conformal Coating Failure Mechanism: Delamination

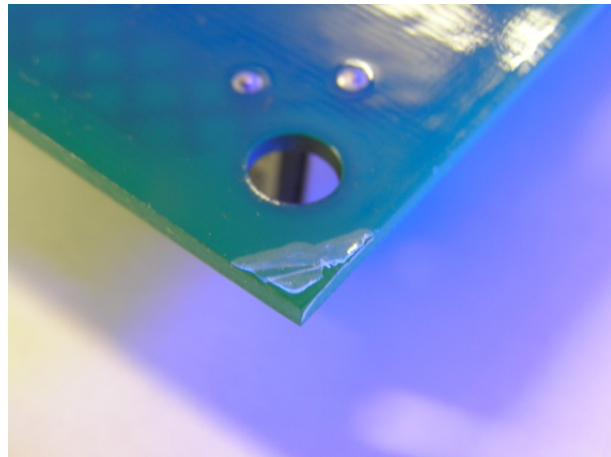
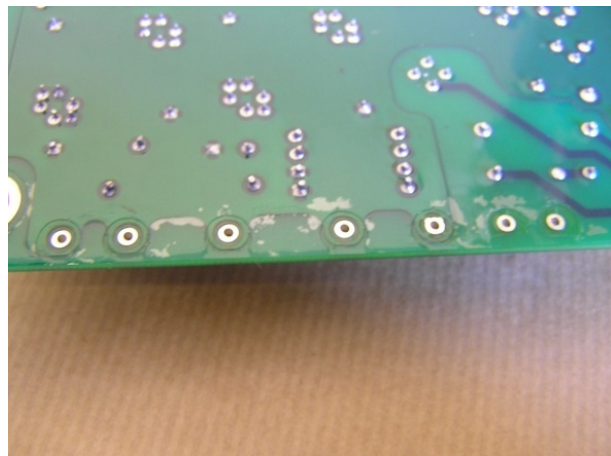
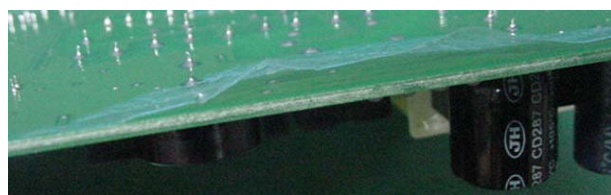
Examples of Conformal Coating Delamination

Delamination in conformal coating is where the coating lifts from the surface of the PCB, leaving the area below exposed.

Examples are shown in the images throughout the bulletin where the conformal coating has lifted away from the surfaces, leaving torn and/or non adhered coating, producing a poor finish.

- Reducing the coating thickness
- Reduce force drying (thermal profile)
- Remove contamination such as mould release agents
- Apply a primer to treat the board surface
- Change the coating and / or surface finish so the surface energies are more favourable.
